**Flood Control Project Maintenance
Levee Inspections**

Maintenance Issue Types Only, Levee Inspection Report By Mile - Spring 2018

Reclamation District No. 0010 Honcut

Waterway	Bank	Unit Miles	Inspection Start/End	Inspector
Unit No. 01 Simmerly Slough	Right	7.65	04/10/2018 04/10/2018	Sterling York

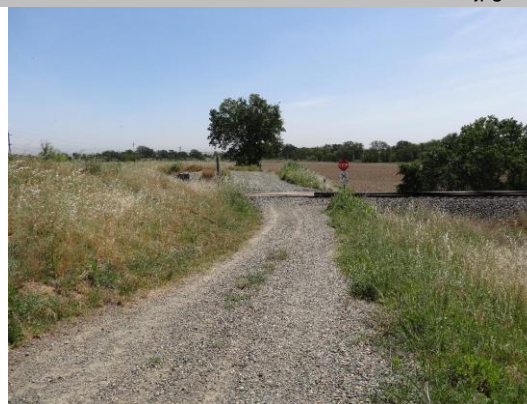
Photo 1 of 3 : UCIP_SP_2018_27791_51501.jpg

LM Start	0.00	Rating **	M	Issue No.	67
LM End	0.00	Issue Type +	Ma	Location *	
Category	Supplemental		GPS Latitude/Longitude		
			Start	End	
Item	DWR UCIP LMA Responsibility		39.169234 °	39.169234 °	
			-121.586203 °	-121.586203 °	
DWR ID					
Comment Code					
Inspector Comment					
FS_ID:27791 DS_ID:21268 EP_NO: N/A Repair Type: Non-Urgent Crossing Status: Found UCIP Comments: Vegetation has been cleared from slope. This crossing is referenced in the USACE Periodic Inspection as item USACE_CESPK_HON1_2013_p_0158. FIELD_STRUCT_DESC: 24-inch corrugated metal gravity drainage pipe through the levee, 30 feet below the crown. Flap gate on the waterside (WS) end. Slide gate on the landside (LS) end. Concrete saddle and apron on the WS. [Additional Reference(s): DWR Levee Log, 2005. USACE Sacramento O&M Manual 151, May 1953, (Station 1+00)]. FS Date: 4/29/2013

View of levee crown looking downstream.

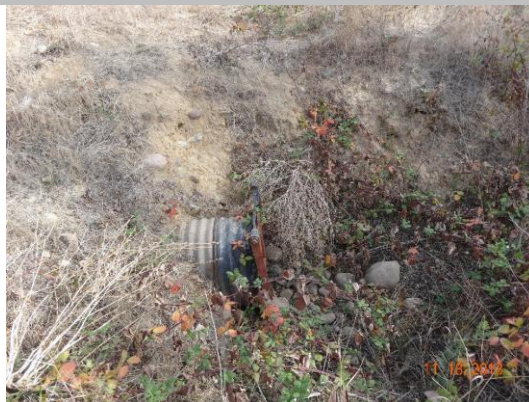
Photo 3 of 3 : UCIP_SP_2018_27791_51504.jpg

FS_ID:27791
DS_ID:21268
EP_NO: N/A
Repair Type: Non-Urgent
Crossing Status: Found
UCIP Comments: Vegetation has been cleared from slope. This crossing is referenced in the USACE Periodic Inspection as item USACE_CESPK_HON1_2013_p_0158.
FIELD_STRUCT_DESC: 24-inch corrugated metal gravity drainage pipe through the levee, 30 feet below the crown. Flap gate on the waterside (WS) end. Slide gate on the landside (LS) end. Concrete saddle and apron on the WS. [Additional Reference(s): DWR Levee Log, 2005. USACE Sacramento O&M Manual 151, May 1953, (Station 1+00)].
FS Date: 4/29/2013

View of pipe and flap gate located on waterward side.

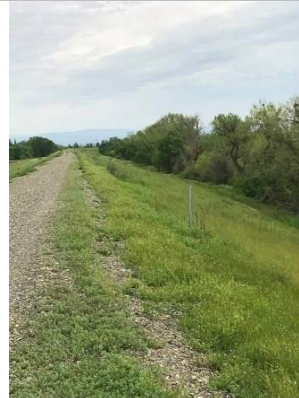
Photo 1 of 1 : SP_2018_RD0010_163_29_20180411_00094.jpg

View looking upstream waterside of maintained annual vegetation, Spring 2018.

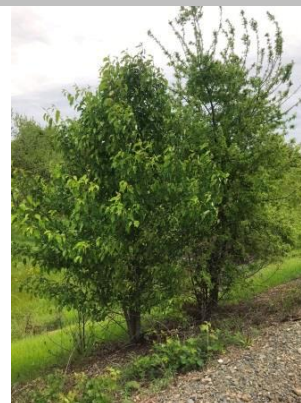
Photo 1 of 1 : SP_2018_RD0010_163_30_20180411_00095.jpg

View looking upstream landside of small trees that need to be trimmed or removed if trunks are 4" at chest height, Spring 2018.

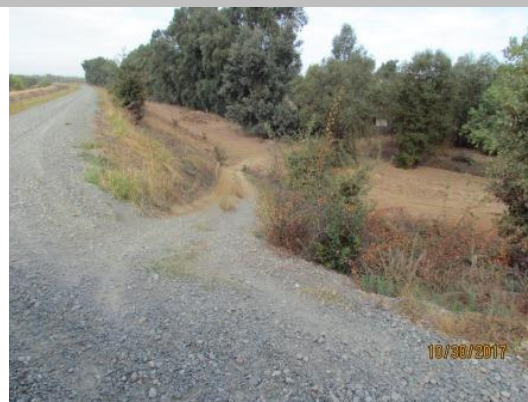
Photo 1 of 1 : SP_2018_RD0010_163_48_20180302_00019.jpg

LM Start	0.72	Rating **	M	Issue No.	48
LM End	0.72	Issue Type +	Ma	Location *	LS
Category	Earthen Levee			GPS Latitude/Longitude	
				Start	End
Item	Slope Stability			39.161198 °	39.161198 °
				-121.597102 °	-121.597102 °
DWR ID	DWR_RD0010_01_f_2013_48				
Comment Code					
S3 : Repair the levee slope damaged by vehicle traffic and prevent access where possible.					
Inspector Comment					
Ramp is caused by constant ATV foot traffic use on levee slope. Fall 2017.

View of the slope stability caused by foot traffic on the landward side of the levee looking downstream. Fall 2017.

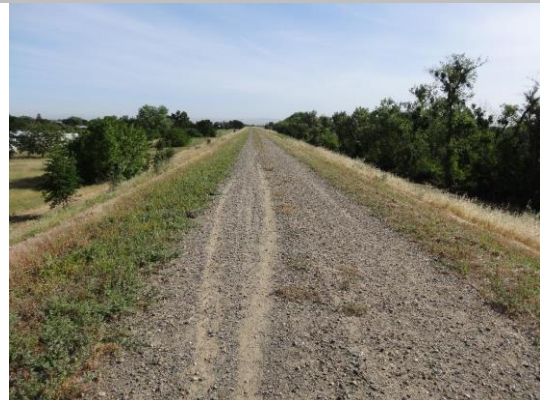
Photo 2 of 3 : UCIP_SP_2018_50058_51410.jpg

View of levee crown looking downstream.

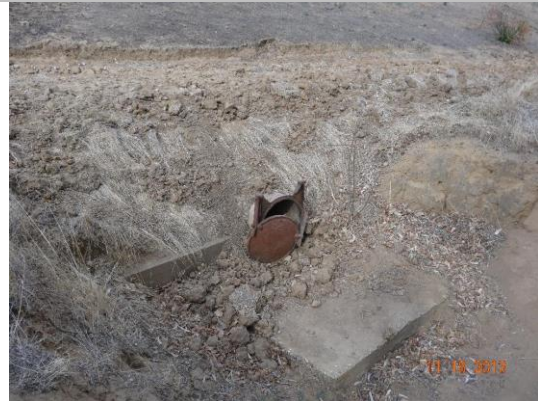
Photo 3 of 3 : UCIP_SP_2018_50058_51414.jpg

FS_ID:50058
DS_ID:21258
EP_NO: N/A
Repair Type: Non-Urgent
Crossing Status: Found
UCIP Comments: 7/01/2016 Gate has been repaired--WS gate is functional. LS gate still needs new stem for the gate to properly function--stem is bent. USACE's PI issue references permit number 13710 this is incorrect permit is associated with DS_ID 21259 (CLM 0.767). (DWR UCIP - omagana)4/29/2013 Damaged flap gate on waterward side and damaged stem on screw gate on landward side. Need to contact owner to determine if crossing is still active. If crossing is still in use owner will need to address damage on flap gate and screw gate. If crossing is no longer in use owner will need to contact the CVFPB to comply with Title 23. This crossing is referenced in the USACE Periodic Inspection as item USACE_CESPK_HON1_2013_p_0053 and 0057. (DWR UCIP - omagana)
FIELD_STRUCT_DESC: 24-inch corrugated metal gravity drainage pipe through the levee, 31 feet below the crown. Two corrugated metal cutoff walls around pipe. Concrete headwall at each end. Flap gate on the waterside (WS) end. Slide gate on the landside (LS) end. Pipe discharges into 6-foot concrete splash apron on the WS. [Additional Reference(s): DWR Levee Log, 2005. USACE Sacramento O&M Manual 151, May 1953, (Station 46+60)].

Damage flap gate located on WS.

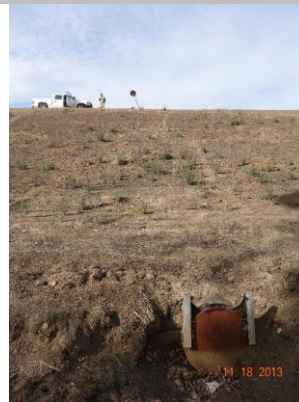
Photo 2 of 3 : UCIP_SP_2018_27748_51450.jpg

View of slope located on waterward side.

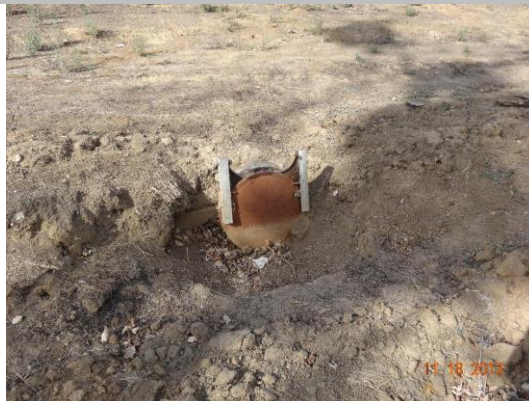
Photo 3 of 3 : UCIP_SP_2018_27748_51451.jpg

Comment Code						
Inspector Comment						
FS_ID:27748						
DS_ID:21261						
EP_NO: N/A						
Repair Type: No Action Needed						
Crossing Status: Found						
UCIP Comments: No signs of damage to levee present during inspection. This crossing is referenced in the USACE Periodic Inspection as item USACE_CESPK_HON1_2013_p_0037 and 0040.						
FIELD_STRUCT_DESC: 24-inch corrugated metal gravity drainage pipe through the levee, 29.5 feet below the crown. Two corrugated metal cutoff walls around the pipe on each end. Slide gate on the landside (LS) end. Flap gate on the waterside (WS) end. Concrete headwall at the LS toe. [Additional Reference(s): DWR Levee Log, 2005. USACE Sacramento O&M Manual 151, May 1953, (Station 37+66)].						
FS Date: 4/29/2013

View of flap gate located on waterward side.

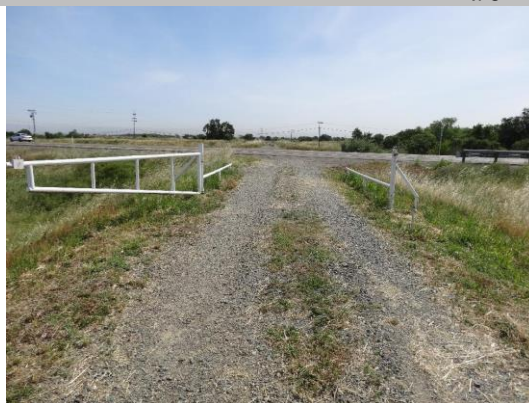
Photo 2 of 3 : UCIP_SP_2018_24811_44581.jpg

View of levee crown looking downstream--access gate near HWY 70.

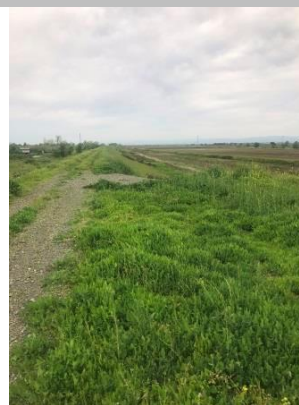
Photo 1 of 1 : SP_2018_RD0010_163_39_20180411_00099.jpg

View looking upstream waterside of overgrown annual vegetation, Spring 2018.

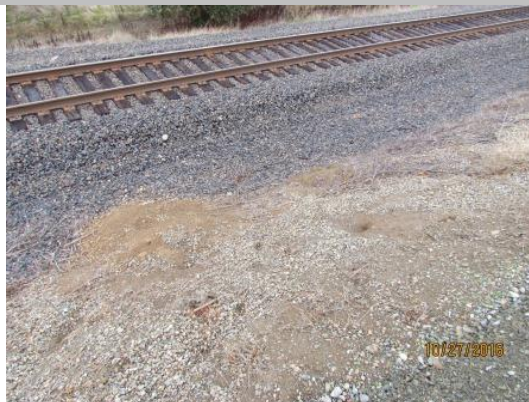
Photo 1 of 1 : SP_2018_RD0010_163_65_20180302_00033.jpg

View of squirrel holes on the landside, no rodent activity was observed. Fall 2016.

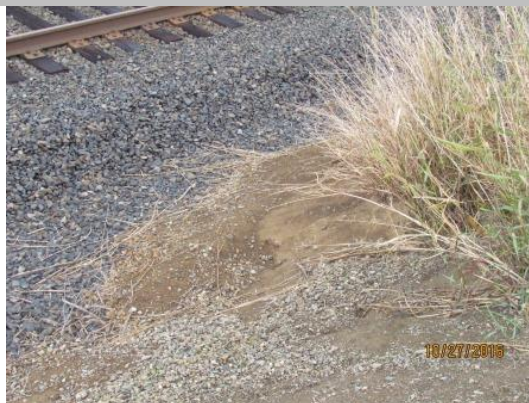
Photo 1 of 1 : SP_2018_RD0010_163_64_20180302_00032.jpg

View of squirrel holes on the landside, no rodent activity was observed. Fall 2016.

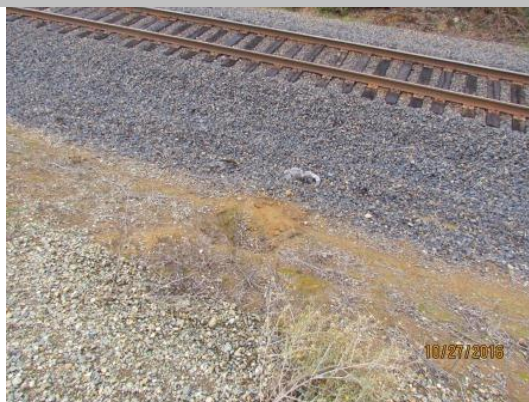
Photo 1 of 1 : SP_2018_RD0010_163_63_20180302_00031.jpg

View of squirrel holes on the landside, no rodent activity was observed. Fall 2016.

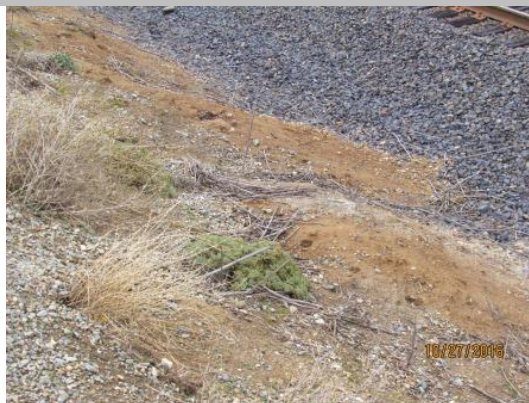
Photo 1 of 1 : SP_2018_RD0010_163_61_20180302_00030.jpg

View of squirrel holes on the landside slope and toe, no rodent activity was observed. Fall 2016.

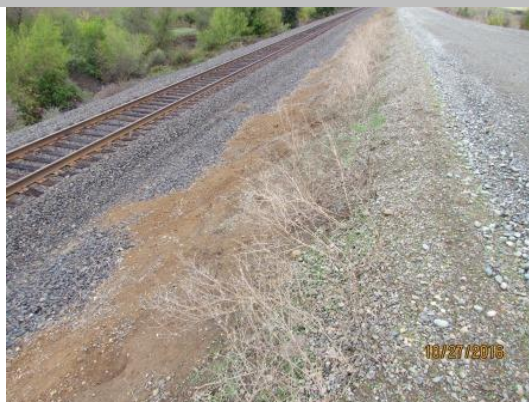
Photo 1 of 1 : SP_2018_RD0010_163_60_20180302_00029.jpg

View of squirrel holes on the landside slope and toe, no rodent activity was observed. Fall 2016.

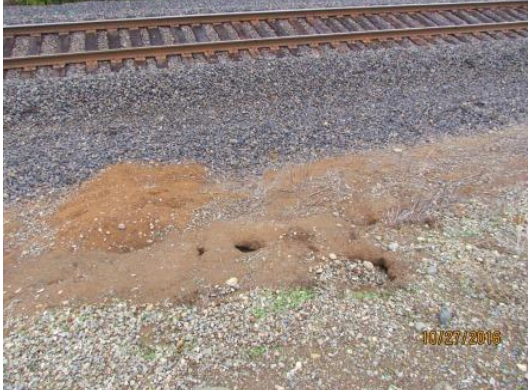
Photo 1 of 1 : SP_2018_RD0010_163_58_20180302_00027.jpg

View of squirrel holes on the landside slope and toe, no rodent activity was observed. Fall 2016.

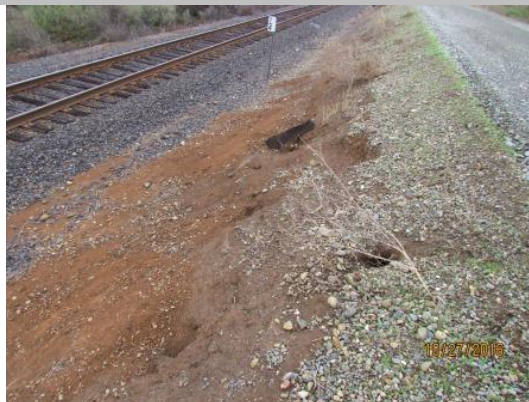
Photo 1 of 1 : SP_2018_RD0010_163_57_20180302_00026.jpg

View of squirrel holes on the landside slope and toe, no rodent activity was observed. Fall 2016.

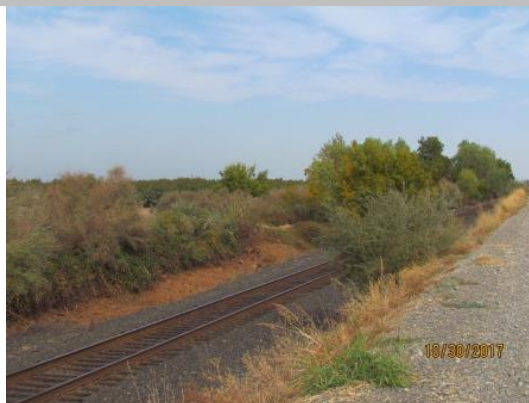
Photo 1 of 1 : SP_2018_RD0010_163_55_20180302_00025.jpg

View of small willow trees on the landside slope looking upstream. Fall 2017.

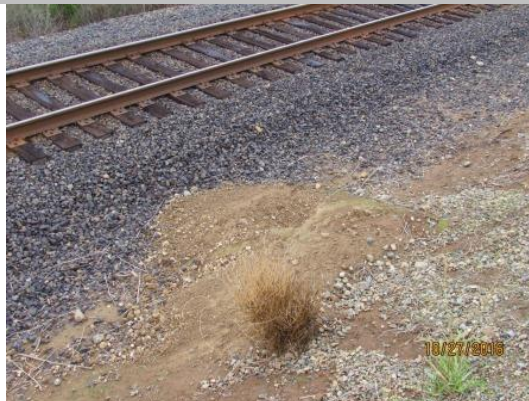
Photo 1 of 1 : SP_2018_RD0010_163_52_20180302_00023.jpg

View of squirrel holes on the landside slope and toe, no rodent activity was observed. Fall 2016.

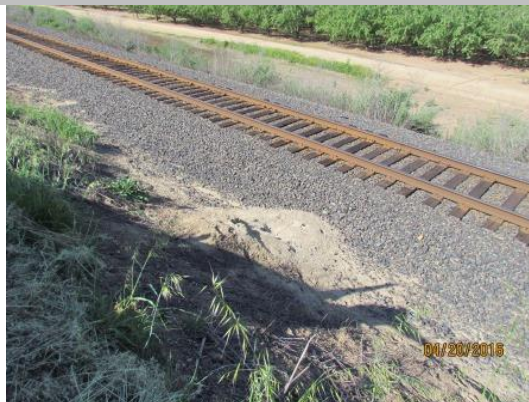
Photo 1 of 1 : SP_2018_RD0010_163_51_20180302_00022.jpg

View of large burrow on landside.

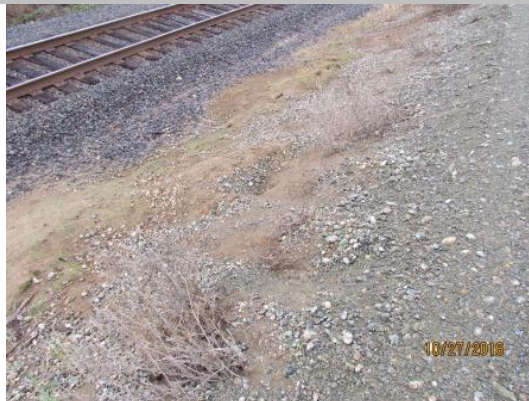
Photo 1 of 1 : SP_2018_RD0010_163_50_20180302_00021.jpg

View of squirrel holes on the landside slope and toe, no rodent activity was observed. Fall 2016.

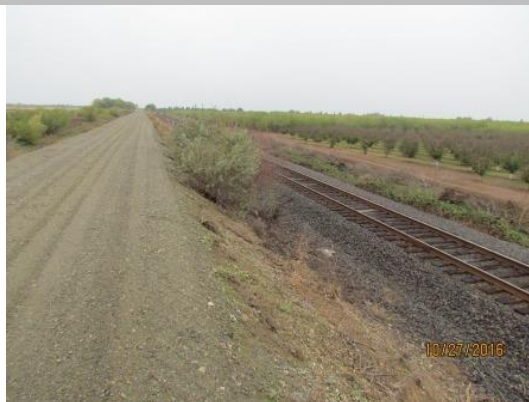
Photo 1 of 1 : SP_2018_RD0010_163_47_20180302_00018.jpg

View of a small willow tree that should be removed on the landside looking down stream. Fall 2016.

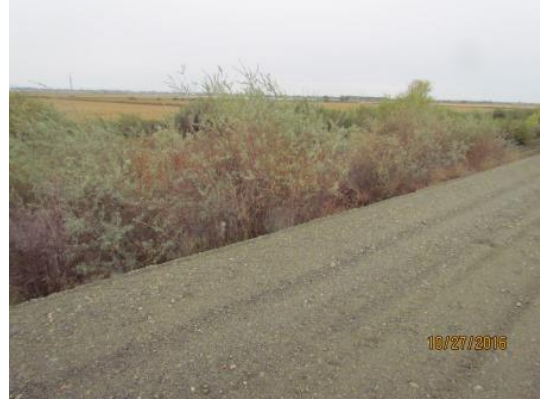
Photo 1 of 1 : SP_2018_RD0010_163_49_20180302_00020.jpg

LM Start	4.50	Rating **	M	Issue No.	46					
LM End	4.50	Issue Type +	Ma	Location *	LS					
Category	Earthen Levee			GPS Latitude/Longitude						
				Start	End					
Item	Animal Control			39.210790 °	39.210790 °					
				-121.580654 °	-121.580654 °					
DWR ID	DWR_RD0010_01_s _2016_46									
Comment Code										
A3 : No rodents visible, but rodent burrows visible; need to backfill and compact or grout burrows.										
Inspector Comment										
Squirrel hole still are visible but no sign of activity, Fall 2017.

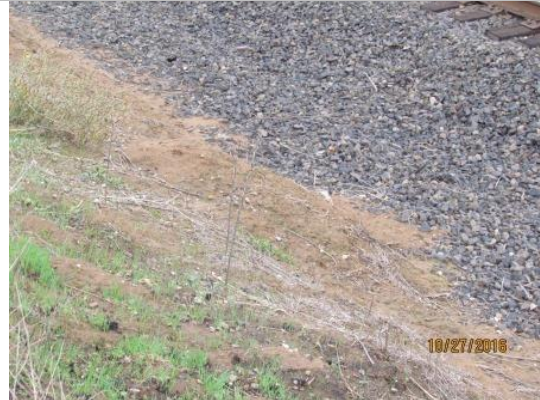
Photo 1 of 1 : SP_2018_RD0010_163_46_20180302_00017.jpg

View of squirrel holes on the landside slope and toe, no rodent activity was observed. Fall 2016.

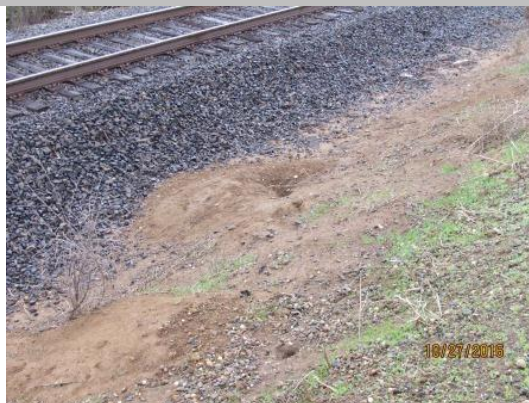
Photo 1 of 1 : SP_2018_RD0010_163_42_20180302_00015.jpg

View of squirrel hole on landside toe, no sign of activity. Fall 2016.

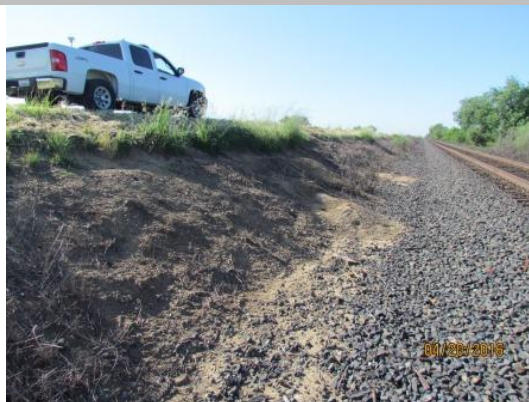
Photo 1 of 1 : SP_2018_RD0010_163_41_20180302_00014.jpg

View of multiple active ground squirrel holes on landside slope looking downstream.

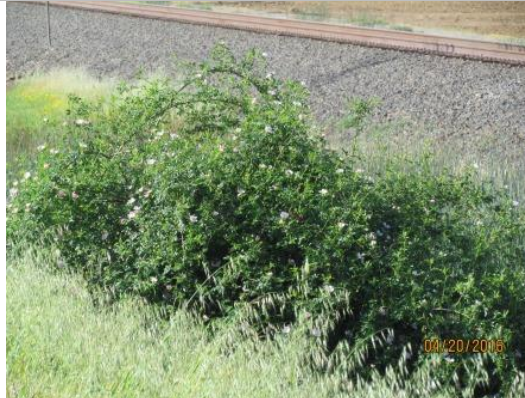
Photo 1 of 1 : SP_2018_RD0010_163_34_20180302_00008.jpg

View of thick wild rose bush that obstructs visibility of the landside slope and toe. Spring 2016.

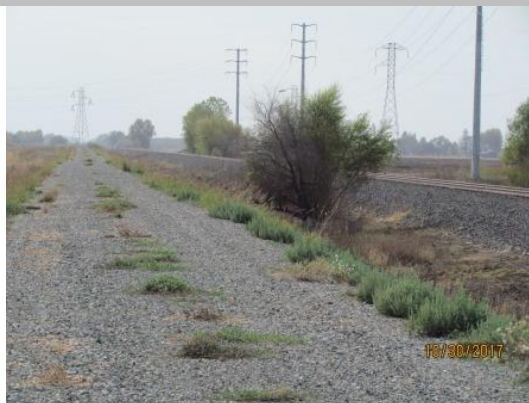
Photo 1 of 1 : SP_2018_RD0010_163_32_20180302_00006.jpg

View of a tree that needs to be removed on the landside toe, looking downstream. Fall 2017.

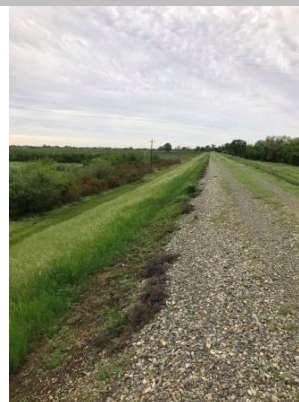
Photo 2 of 2 : SP_2018_RD0010_164_26_20180411_00103.jpg

Second view looking downstream landside of the well maintained annual vegetation, Spring 2018.

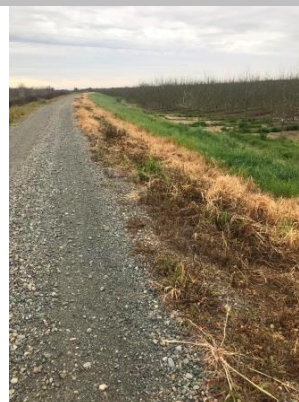
Photo 2 of 2 : SP_2018_RD0010_164_38_20180411_00105.jpg

View looking downstream waterside of the well maintained annual vegetation, Spring 2018.

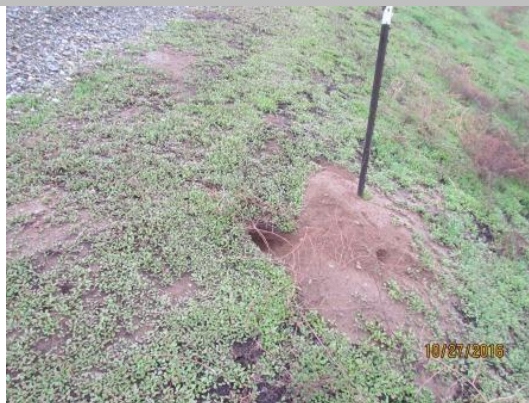
Photo 1 of 1 : SP_2018_RD0010_164_28_20180302_00003.jpg

View of squirrel hole on the waterside looking downstream. Fall 2016

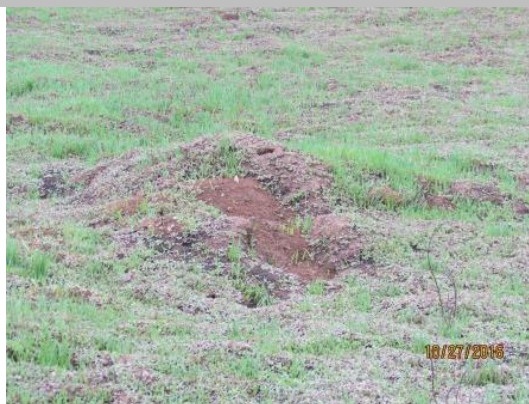
Photo 1 of 1 : SP_2018_RD0010_164_29_20180302_00004.jpg

View of rodent hole that has more than 2 cubic feet of material on the waterside.

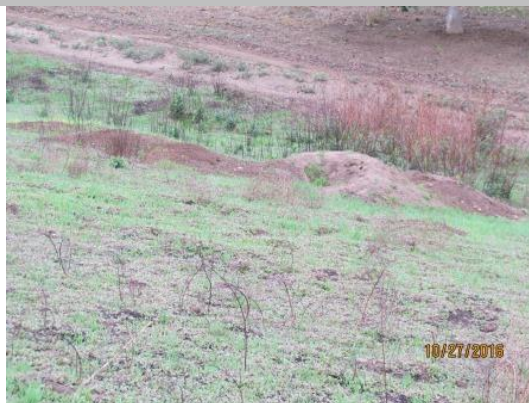
Photo 1 of 1 : SP_2018_RD0010_164_30_20180302_00005.jpg

View of rodent hole that has more than 2 cubic feet of material on the waterside.

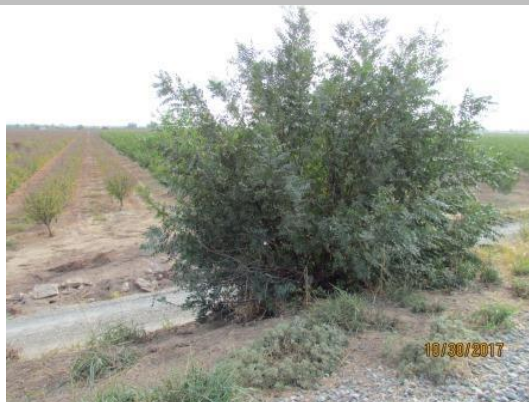
Photo 1 of 1 : SP_2018_RD0010_164_56_20180302_00028.jpg

View looking downstream landside of a tree less than 4" in diameter that needs to be removed, Fall 2017.

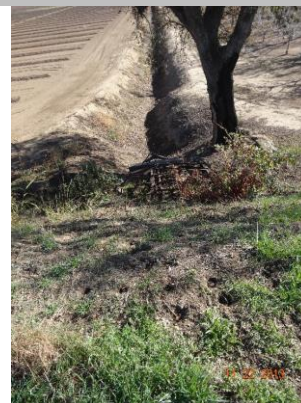
Photo 3 of 3 : UCIP_SP_2018_24824_44656.jpg

Comment Code						
Inspector Comment						
FS_ID:24824						
DS_ID:21284						
EP_NO: N/A						
Repair Type: Non-Urgent						
Crossing Status: Found						
UCIP Comments: Remove concrete piece preventing complete closure of screw gate on landward side. This crossing is referenced in the USACE Periodic Inspection as item						
USACE_CESPK_HON2_2013_p_0152.						
FIELD_STRUCT_DESC: 36-inch corrugated metal gravity drainage pipe through the levee, 24 feet below the crown. Corrugated metal cutoff wall around the pipe at each shoulder. Flap gate on the waterside (WS) end. Slide gate on the landside (LS) end. Concrete headwall at each end.						
[Additional Reference(s): DWR Levee Log, 2005. USACE Sacramento O&M Manual 151, May 1953, (Station 259+76)].						
FS Date: 4/30/2013

View of landward side--barrier used to discourage damage to crossing near toe.

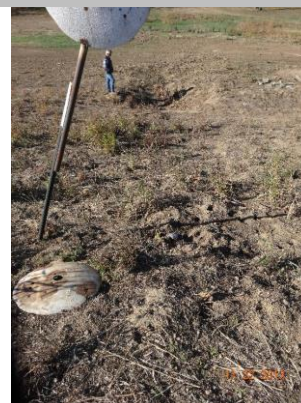
Photo 1 of 1 : SP_2018_RD0010_164_7_20180302_00001.jpg

View of waterward slope--burrow activity present.

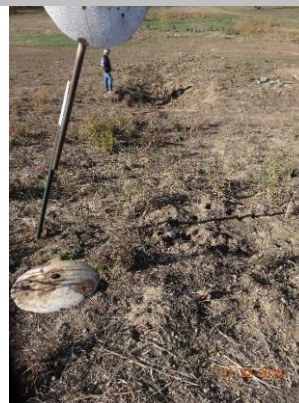
Photo 2 of 3 : UCIP_SP_2018_24825_44663.jpg

View of waterward slope--burrow activity present.

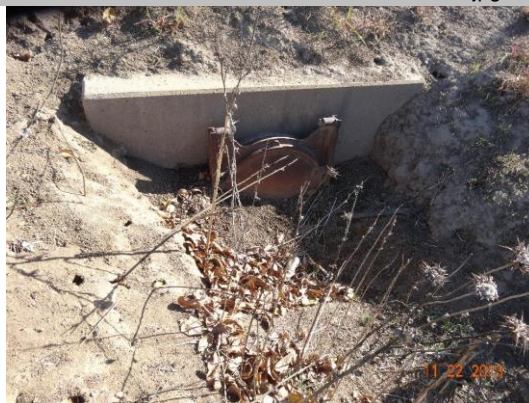
Photo 3 of 3 : UCIP_SP_2018_24825_44662.jpg

Flap gate located on waterward side--debris blocking gate.

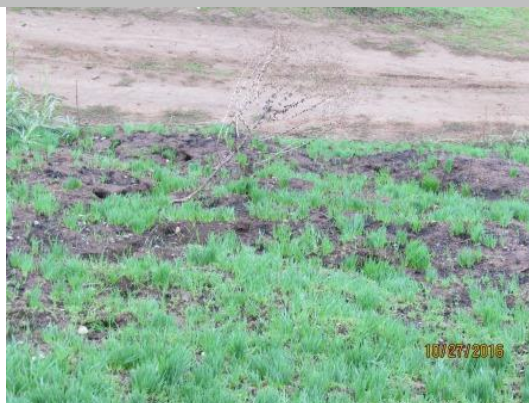
Photo 1 of 1 : SP_2018_RD0010_164_68_20180302_00033.jpg

View of rodent holes on waterside slope, no evident of rodent activity Spring 2017.

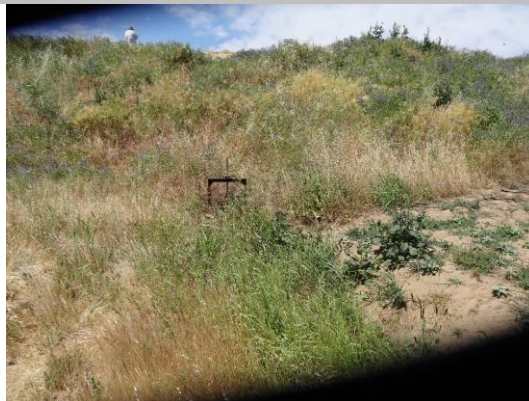
Photo 3 of 3 : UCIP_SP_2018_24751_44373.jpg

View of landward side--dense vegetation.

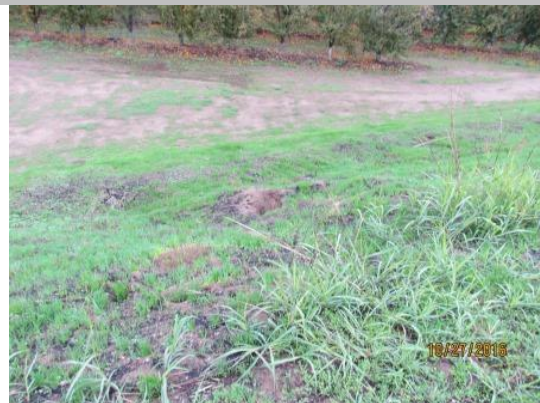
Photo 1 of 1 : SP_2018_RD0010_164_50_20180302_00023.jpg

View of rodent hole on landside slope. Fall 2016.

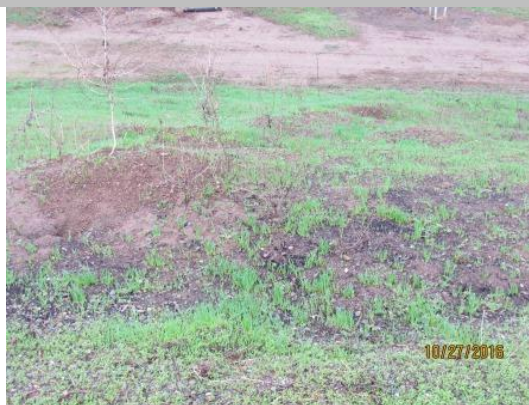
Photo 1 of 1 : SP_2018_RD0010_164_32_20180302_00008.jpg

View of rodent holes on waterside levee slope.

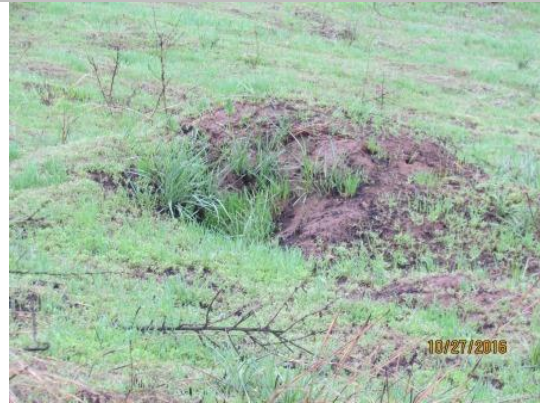
Photo 1 of 1 : SP_2018_RD0010_164_33_20180302_00009.jpg

View of rodent hole that has more than 2 cubic feet of material, this hole is not active but needs to be backfilled properly.

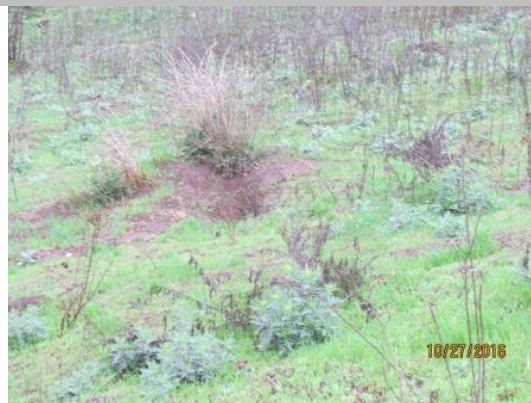
Photo 1 of 1 : SP_2018_RD0010_164_35_20180302_00012.jpg

View of rodent hole on waterside.

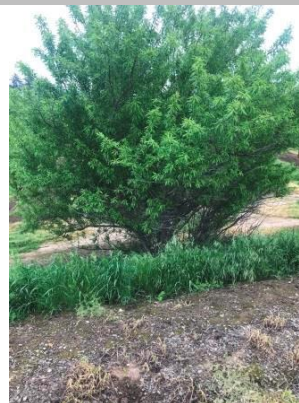
Photo 1 of 1 : SP_2018_RD0010_164_66_20180411_00108.jpg

View of small peach tree on the landside toe looking downstream that should be removed, Spring 2018.

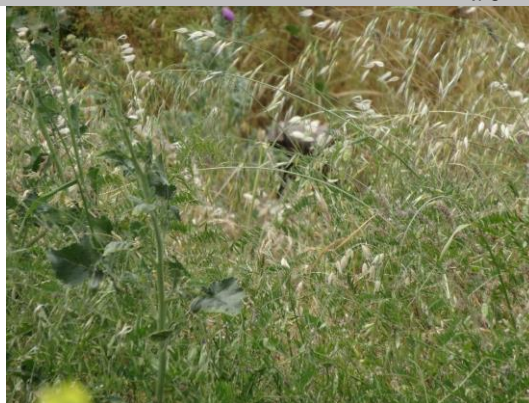
Photo 2 of 3 : UCIP_SP_2018_24768_44451.jpg

Dense vegetation on landward side.

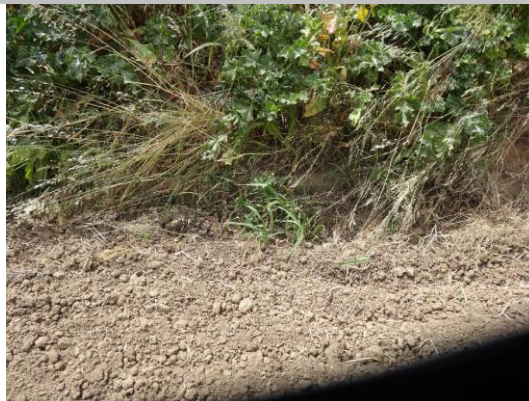
Photo 3 of 3 : UCIP_SP_2018_24768_44449.jpg

View of concrete headwall visible through dense vegetation.

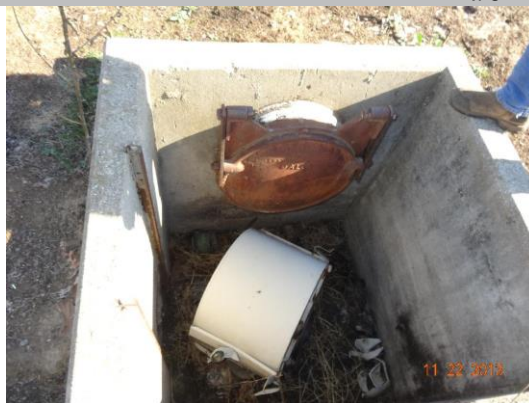
Photo 2 of 3 : UCIP_SP_2018_24769_44453.jpg

View of flap gate located inside concrete distribution box. Debris scattered inside box.

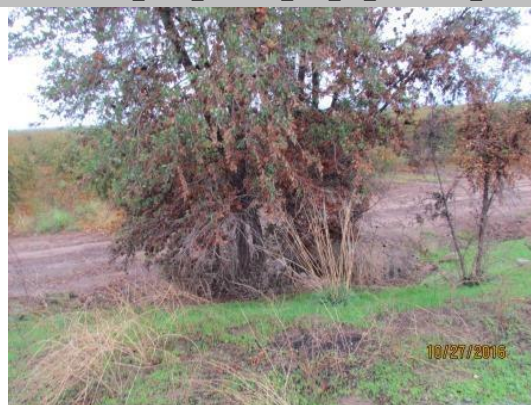
Photo 1 of 1 : SP_2018_RD0010_164_70_20180302_00035.jpg

View of tree on landside toe that need to be trimmed up five feet for visibility and access.

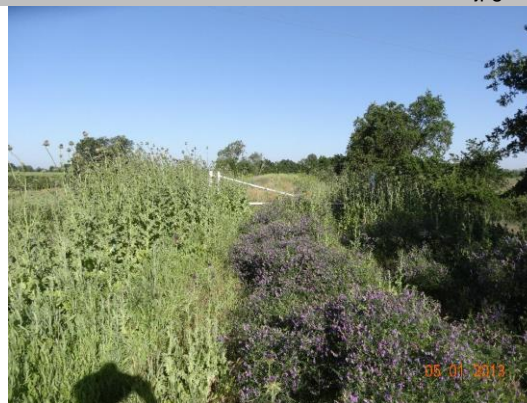
Photo 2 of 2 : UCIP_SP_2018_24883_44821.jpg

View of levee crown--dense vegetation.
